The Bakersfield Fire

By Bill Brooks, PE

A Lesson in Ground-Fault Protection

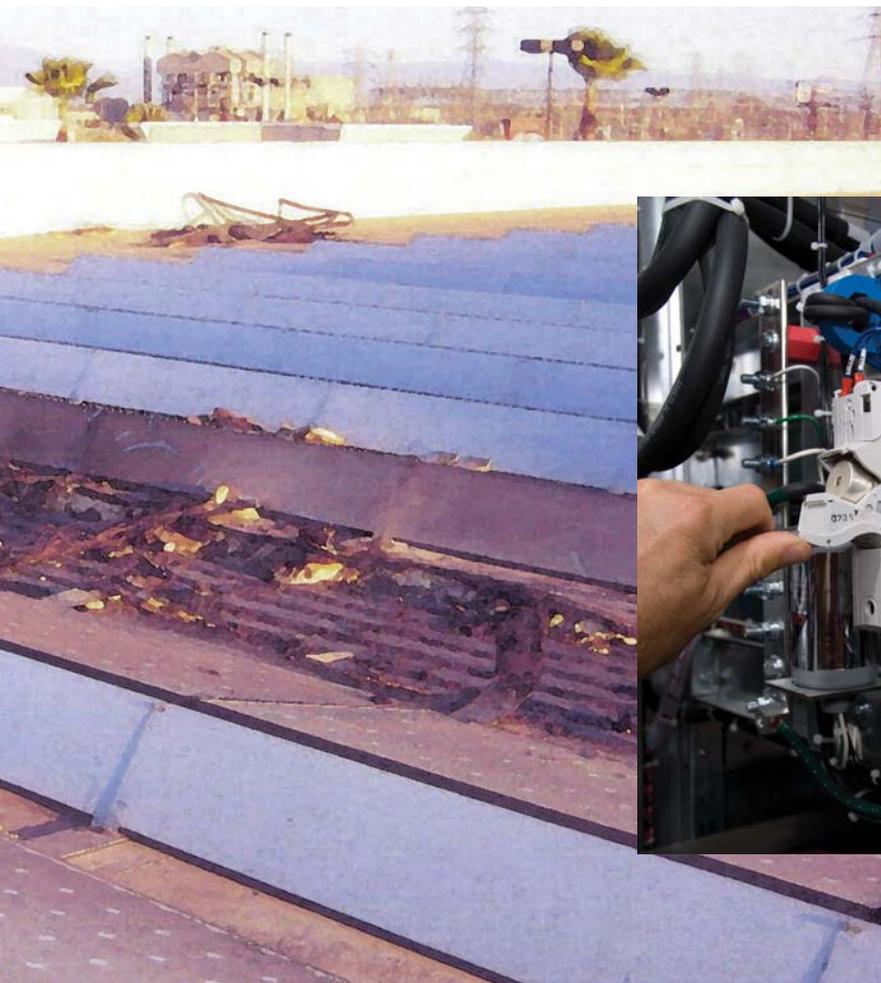
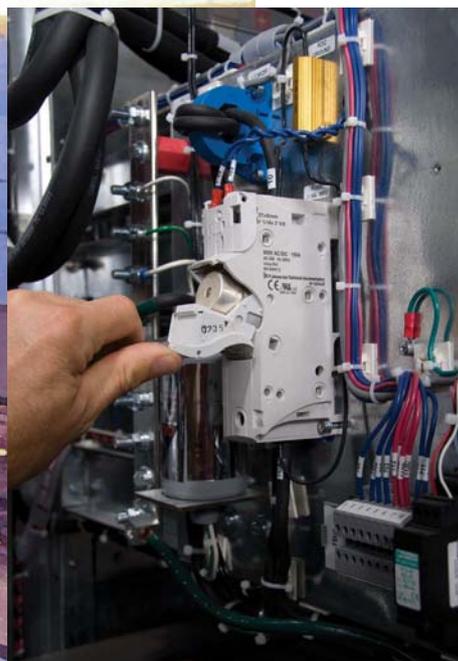
GFP blind spot The leading theory regarding the root cause of the Bakersfield Fire is that a fault-to-ground in a grounded current-carrying source-circuit conductor went undetected by the inverter's ground-fault protection device.

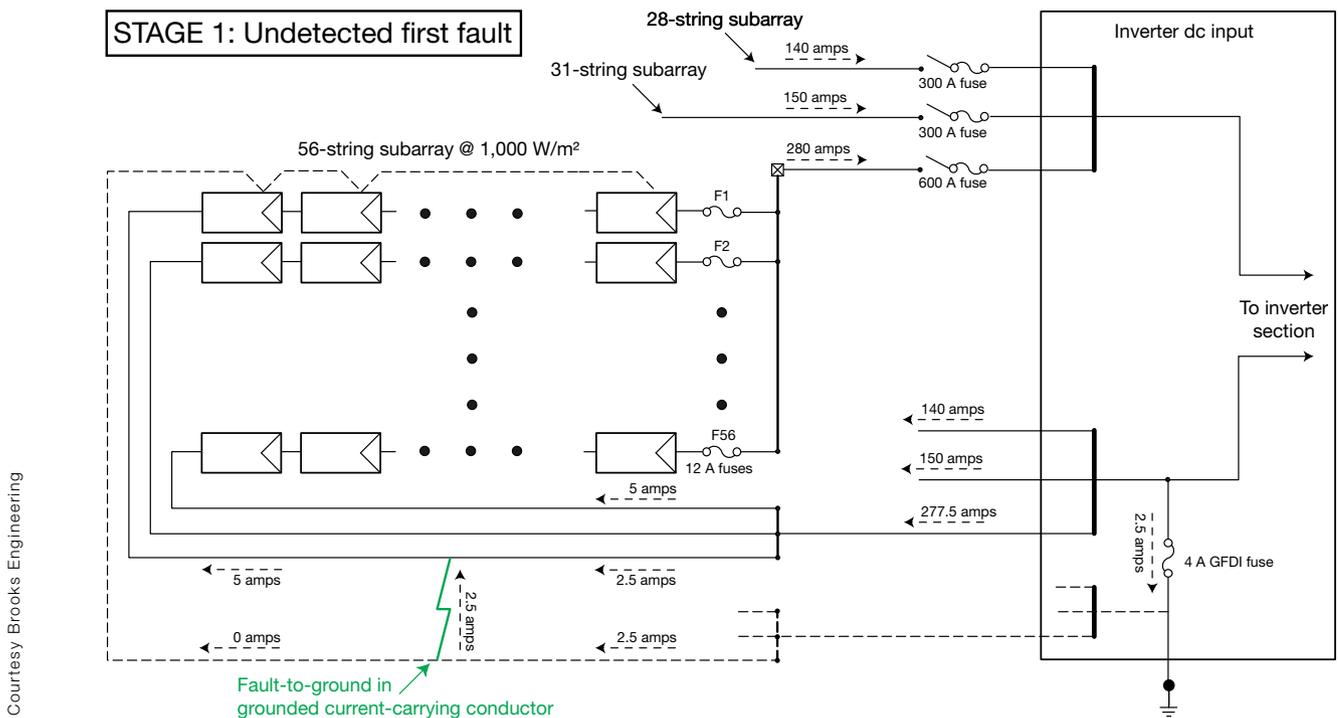
Figure 1 An undetected fault between a grounded current-carrying conductor and the equipment-grounding conductor will persist indefinitely without tripping the GFP. Absent proper commissioning procedures, this first fault can exist from the time of installation forward.

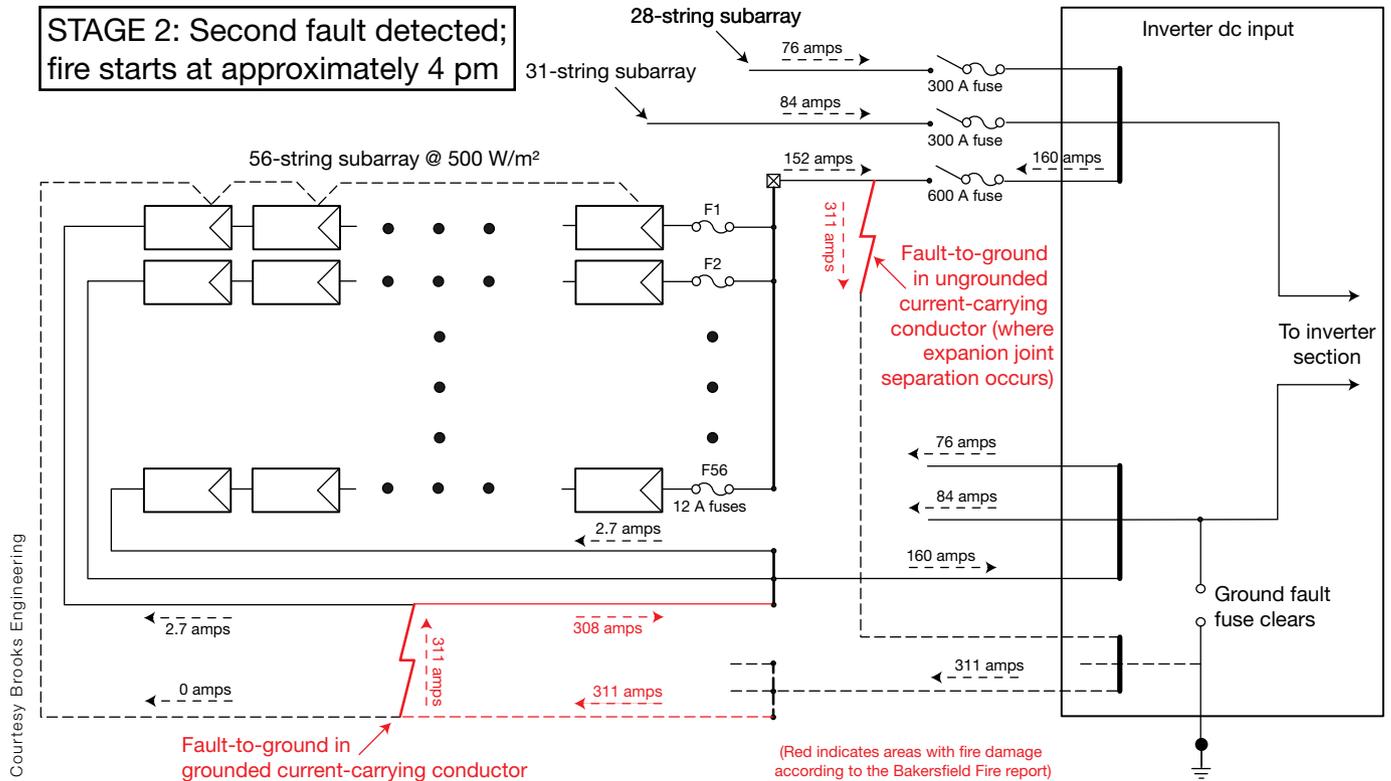
Figure 2 Thermal expansion in a long conduit run housing PV output-circuit conductors causes an expansion joint to fail and damage a large (500 MCM) ungrounded output cable. The resulting high-magnitude ground-fault currents quickly clear the ground-fault fuse in the inverter. After the ground connection is lifted at the inverter, the available ground currents return through the fault in the grounded source-circuit conductor (through the array-bonding hardware and the metal conduit parts) to the fault in the ungrounded output conductor. Because the grounded conductor is unfused, these high-magnitude fault currents continue without interruption.

as shown in Figure 2, then the GFP fuse instantly opens, removing the main ground connection on the array.

However, this is exactly what *should not* happen if there is already a fault in the array. Now, instead of having a large equipment-grounding conductor to carry the fault current, a 10 or 12 AWG source-circuit conductor has to carry the entire return current. This means that the short-circuit current now has to return through the point where the first undetected fault occurred, as shown in Figure 2. Within several seconds that conductor can get so hot that the insulation on the conductor melts or catches fire. The fire is then driven into whatever flammable material is in proximity to the wire, such as the flammable PV module backsheet or any flammable roof materials.

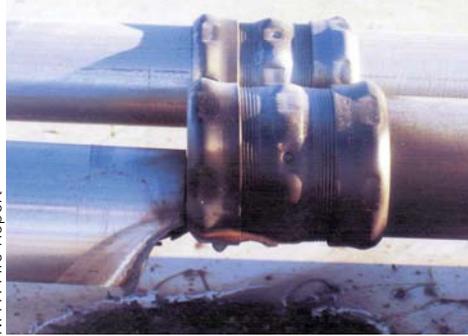
Uninterrupted fault The failure of an improperly specified and installed expansion joint likely triggered the Bakersfield Fire. However, if this had been the first fault in the system, the GFP device would have been able to detect and interrupt the fault before any damage was done.

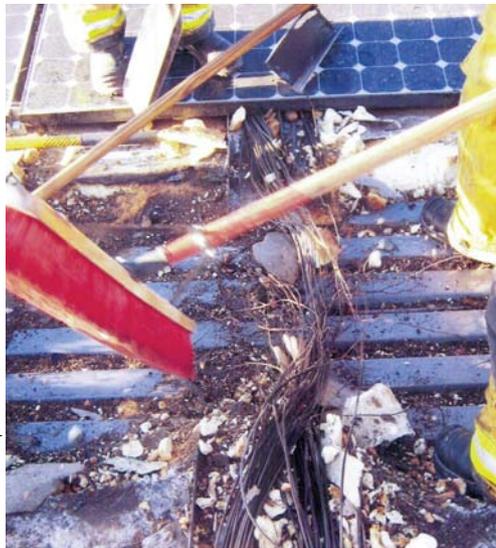
Undetected fault The possibility of an undetected first fault in PV source-circuit conductors underscores the importance of proper commissioning procedures and improved wire management practices throughout the industry.

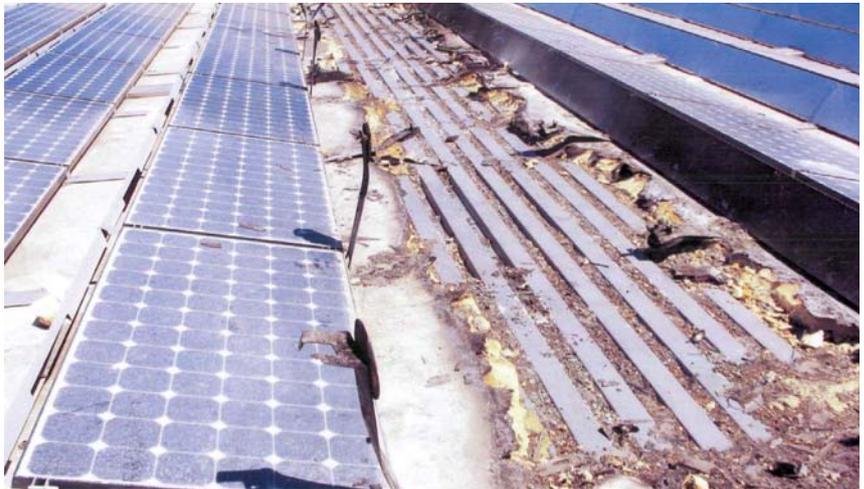
Next steps While arc-fault detection will undoubtedly lead to safer PV installations, it could not have prevented the Bakersfield Fire. The first priority, therefore, is to improve the sensitivity of our ground-fault protection circuits.
